GRADING AREA DISCHARGE WHITE POWDER & GRADING PAINT DAMAGED

Company: BC Hydro
Ratings: 457 MVA, 16 kV, Air Cooled Hydro Generator
Manufacturer: Confidential
Related Info: 30 years old
PD Sensors: Four PDA Couplers per phase
Details:

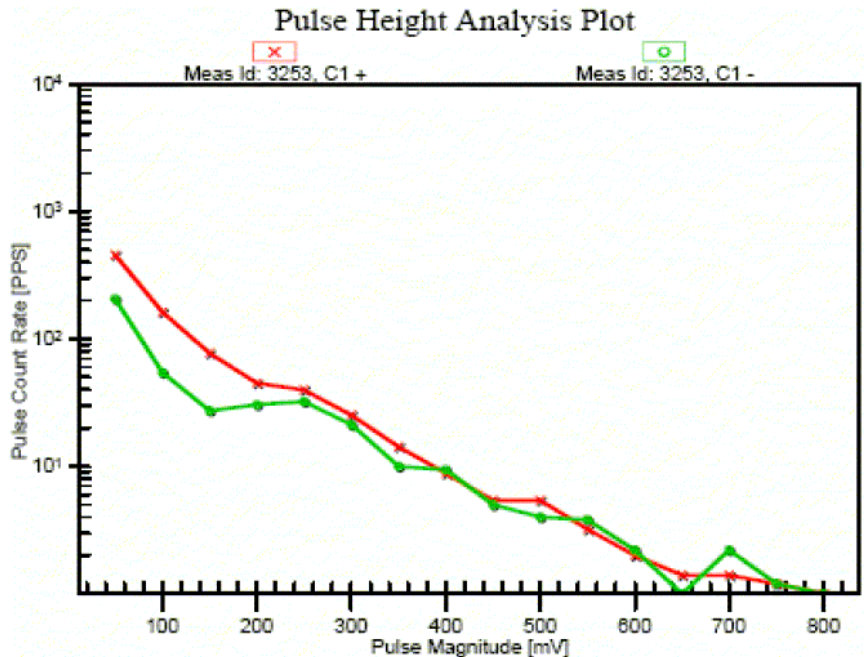
Figure 1. 2D PD Plot with No Polarity Predominance – Phase A

“...This winding was subjected to severe discharge in the grading paint area. White powder and grading paint damaged due to PD were observed at both the top and bottom ends of the bars...These bars were at high potential...In the 2D plot, the PD pattern showed no polarity predominance between the positive and negative pulses. Also, a linear decrease in pulse density with increase in pulse magnitude was shown....”
